Safety Action Notice

SAN2203

Reusable Sling Checks: Joerns Healthcare Technical Bulletin 0442

BULLETIN SUBJECT:
Oxford Slings: Identification of Seam Slippage

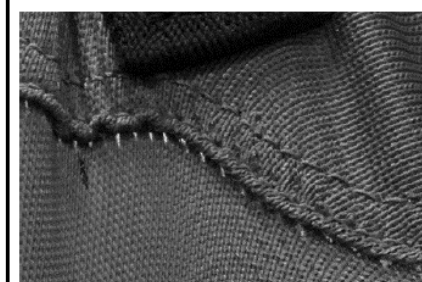
Seam slippage (needle hole elongation) can occur under load in any area of a sling where a needle and thread has passed through the sling fabric as part of the manufacturing process. It is commonly associated with the shoulder quadrants of a sling where load stress is most evident, especially under higher loads. Once the load is removed, seam slippage, where visible, will contract and the area will revert to its former state. See below photos.

Seam Slippage Under Load

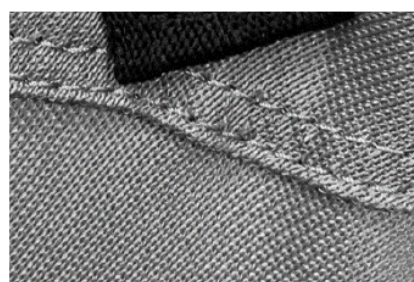
Seam Slippage Following Removal of Load
