Detailed RAAC Inspection Report

Project Name:	NHS RAAC Inspections
Project Number:	UK0037298
Inspection Date:	18 Sep 24
Engineers:	#011, #012, #003, #025
Checker:	#011
Approver:	#002
Issue date:	11 Nov 24

NHS Board:	Lothian
Site Code:	S116H
Site Name:	Western General Hospital
Block Number:	5S
Block Name:	NTSU Block (Ward 1)
Discovery Report:	WSP-RP286-S116H-5S-Western General Hospital_NTSU Block (WARD 1)
Structural Engineers:	#015, #002
NHS Estates:	Connor Wilkie, Owen McCabe, Clive Armstrong

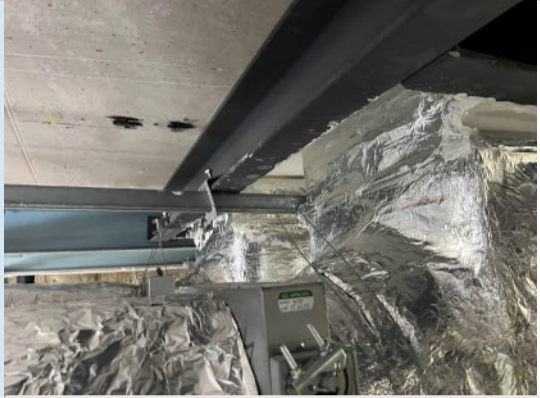
Location	General Condition Code	Repair Detail		Image
		Drawing No.	Detail No.	
P1	AMB.1.2.Edg.4.NR.5.D600x1300.7	N/A	N/A

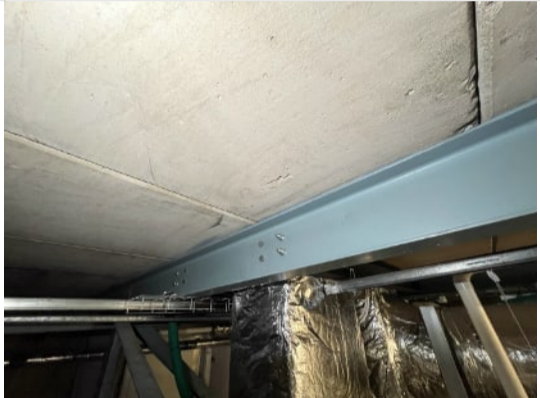
P2	GRY.Mid.NR.5.D600x1800.7	N/A	N/A

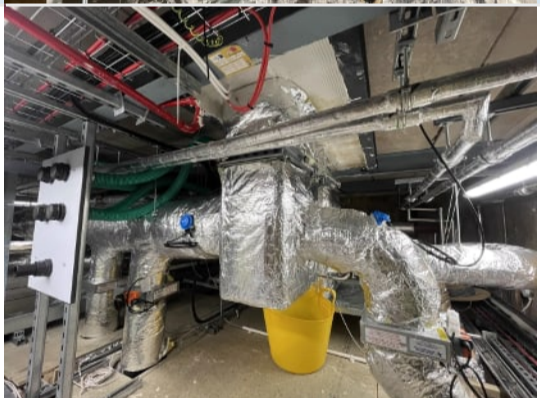
P4	GRY.Edg.4.R.5.D600x1800.7	N/A	N/A

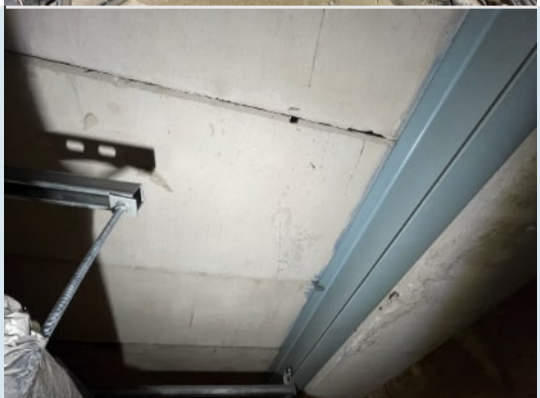
Plank between Truss 1 and 2	RED.1.Edg.4.R.D-	S-00001	04

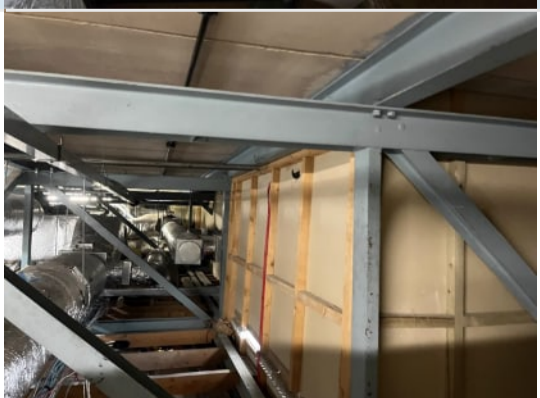
S1	GRY	N/A	N/A

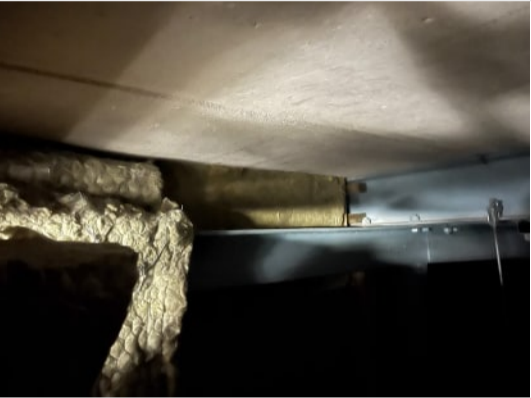
Location	General Condition Code	Repair Detail		Image
		Drawing No.	Detail No.	
S2	GRY	N/A	N/A	
S3	GRY	N/A	N/A

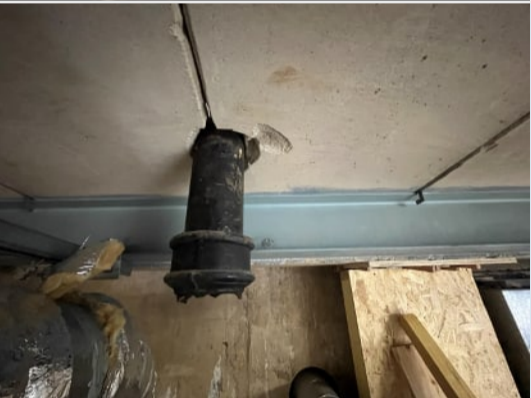
V1	RED.1.2.Mid.4.R.5.D~175mm DIA Opening, ~100mm DIA Pipe	S-00001	04

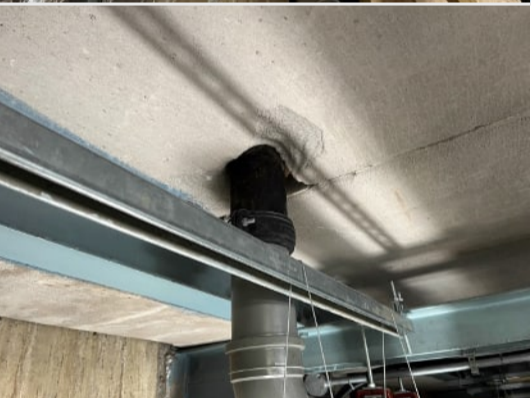
V2	RED.1.2.Edg.4.NR.5.D120mm DIA Opening, 100mm DIA Pipe	S-00001	04

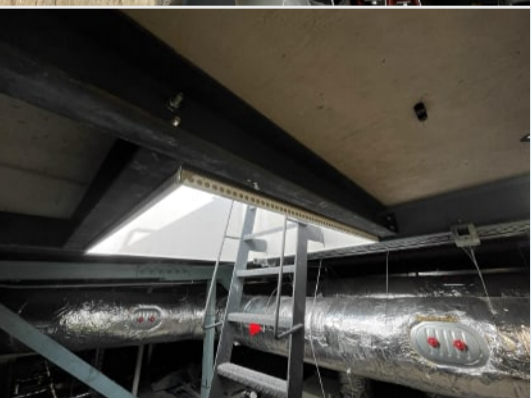
V3	600	100	6	Yes	Yes	<500mm	No	No	No	Yes	1200x1300mm	No	Yes	No	No	No	Green	N/A	N/A	(V3) 2 planks cut to form opening, leaving 600mm long planks supported by 150x75 PFC trimming steel to edges. Hairline cracks present at adjacent planks, but cut planks exhibit no obvious signs of damage.
V4				Yes	Yes	<500mm	No	No	No	Yes	~65mm DIA Opening, 60mm DIA Pipe	No	No	No	No	No	Red	S-00001	4	(V4) Supported on longitudinal beams, no trimming present. No major cracking, no moisture and no spalling observed, 1No. hairline crack from edge of cored opening. Mitigated risk due to load capacity utilisation, dependent on active management strategy and remedial details being implemented in the short term future.
V5	1818	100	18	No	No	>500mm	No	Yes	Yes	Yes	375mm DIA Pipe	No	No	No	No	No	Red	S-00001	4	(V5) Plank spans between longitudinal beams, core at edge of plank. Spalling 200mm long and 30mm deep noted, 400mm from bearing. Longitudinal bars exposed within core. No trimming elements. No sign of moisture and distress. Mitigated risk due to load capacity utilisation, dependent on active management strategy and remedial details being implemented in the short term future.

V3	GRN.1.2.Edg.NR.5.D1200x1300mm.7	N/A	N/A

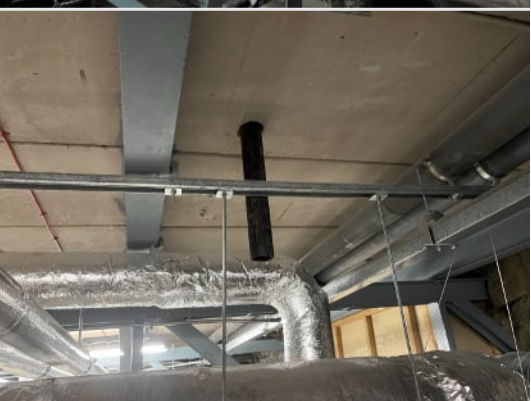
V4	RED.1.2.Edg.NR.5.D~65mm DIA Opening, 60mm DIA Pipe	S-00001	04

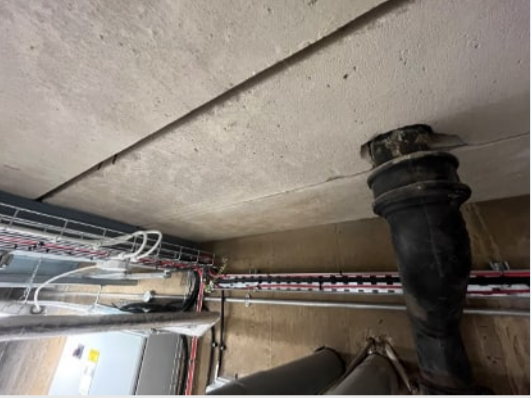
Location	General Condition Code	Repair Detail		Image
		Drawing No.	Detail No.	
V5	RED.Mid.4.R.5.D375mm DIA Pipe	S-00001	04

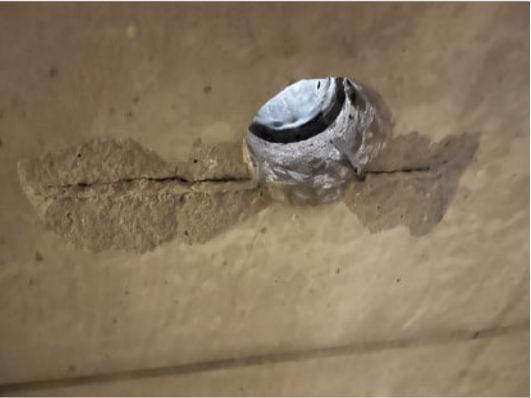
Location	General Condition Code	Repair Detail		Image
		Drawing No.	Detail No.	
V11	GRY	N/A	N/A	
V12	RED.2.Edg.4.R.5.D120~130mm DIA Opening	S-00001	04

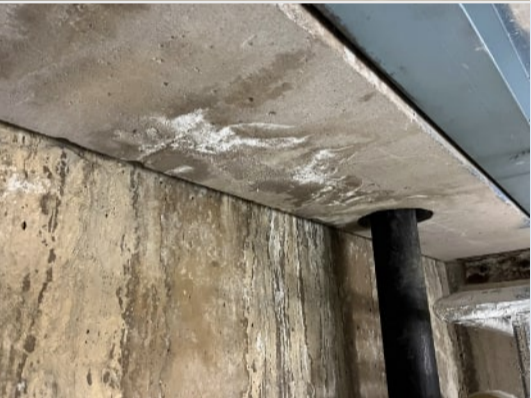
V13	3720	200	19	Yes	No	>500mm	No	No	No	Yes	170mm DIA Opening	No	No	No	Yes	Yes		S-00001	4	(V13) Gutter plank circa 200mm deep. Efflorescence noted in some areas. Hairline crack midspan ~0.3mm wide. Evidence of deflection midspan circa 20mm. No evidence of cracking at the ends. 100x75mm angle, 300mm long fixed to wall to support plank end, truss supports plank at other end. Mitigated risk due to load capacity utilisation, dependent on active management strategy and remedial details being implemented in the short term future.
V14				Yes	Yes	<500mm	No	Yes	No	Yes	200x200 Opening, 200mm DIA Pipe	No	No	No	No	No		S-00001	4	(V14) Opening formed adjacent to longitudinal beam at end of span, no trimming elements present. Some efflorescence noted. Hairline to minor cracking propogating in several directions from opening, circa 350mm long. Mitigated risk due to load capacity utilisation, dependent on active management strategy and remedial details being implemented in the short term future.

V13	RED.1.Mid.NR.5.D170mm DIA Opening.9.10	S-00001	04

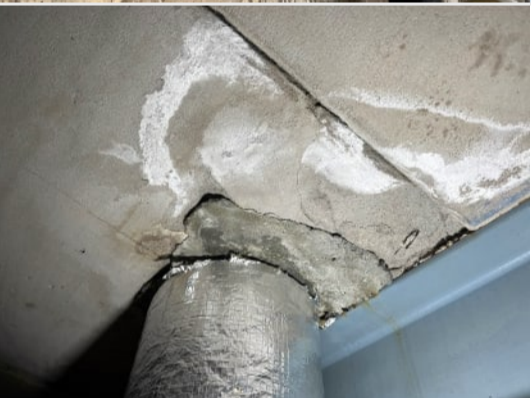
V14	RED.1.2.Edg.4.NR.5.D200x200 Opening, 200mm DIA Pipe	S-00001	04

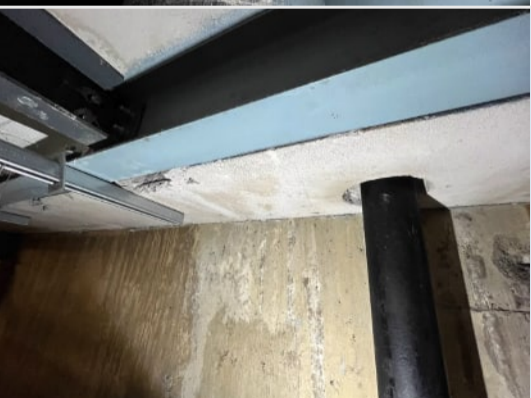
V15				Yes	No	>500mm	No	Yes	Yes	Yes	200mm DIA Pipe	No	No	No	No	Yes		S-00001	4	(V15) Gutter plank locally broken out to install trimming steelwork for opening P3. Reveals longitudinal reinforcement top and bottom with ~20mm cover. Downpipe circa 550mm from PFC installation damage noted and 1150mm from truss, hairline crack 175mm from opening. Mitigated risk due to load capacity utilisation, dependent on active management strategy and remedial details being implemented in the short term future.
V16				No	No	>500mm	No	No	No	Yes	200mm DIA Pipe	No	No	No	No	Yes		S-00001	4	(V16) Opening formed in gutter plank for presumed rainwater pipe. Although no water present during inspection, some evidence of efflorescence and staining. Midspan deflection noted to plank, circa span/200. Mitigated risk due to load capacity utilisation, dependent on active management strategy and remedial details being implemented in the short term future.

V15	RED.1.Mid.4.R.5.D200mm DIA Pipe.10	S-00001	04

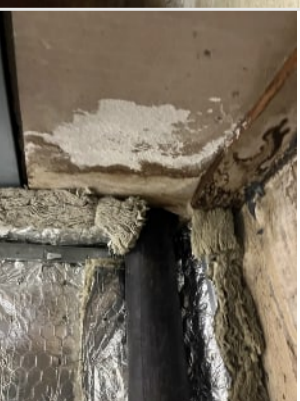
V16	RED.Mid.NR.5.D200mm DIA Pipe.10	S-00001	04

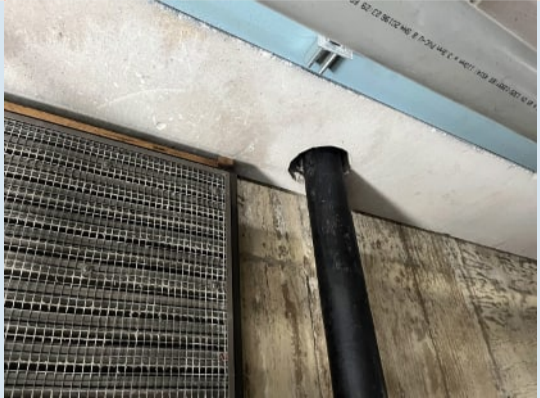
V17	3770	200	19	No	No	>500mm	No	No	No	Yes	200mm DIA Opening	No	No	No	No	No		S-00001	4	(V17) ~200 dia opening formed in gutter plank for presumed rainwater pipe, 70mm to long edge of plank one side, 170mm to other. Circa >500mm to plank support. Deflection mid span. Truss offers 75mm support to end of plank. Mitigated risk due to load capacity utilisation, dependent on active management strategy and remedial details being implemented in the short term future.
Gutter Plank (Near V1)	3725	200	19	Yes	Yes	<500mm	No	Yes	Yes	No	-	No	No	No	No	Yes		S-00001	4	(Gutter Plank (Near V1)) 3725mm span. Angle support 100x70mm 300mm long, 2 M20 bolts fixing to wall truss support at other end of plank. 1200mm long spalling from angle support, notable damage and deflection of 20mm. Notable mortaring to underside, perhaps previous repair. Hairline cracks present. Bottom reinforcement exposed. Currently propped by timber shutter within span, hence risk rating mitigated to red.

Location	General Condition Code	Repair Detail		Image
		Drawing No.	Detail No.	
V17	RED.Mid.NR.5.D200mm DIA Opening	S-00001	04
