Estates and Facilities Notice

Reference: EFN2501

Issued: 21 May 2025

GS Yuasa SWL1100FR Lead Acid Battery: reports of smoking and electrical fires in UPS systems

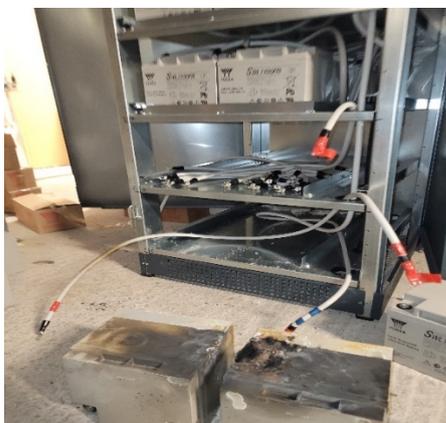
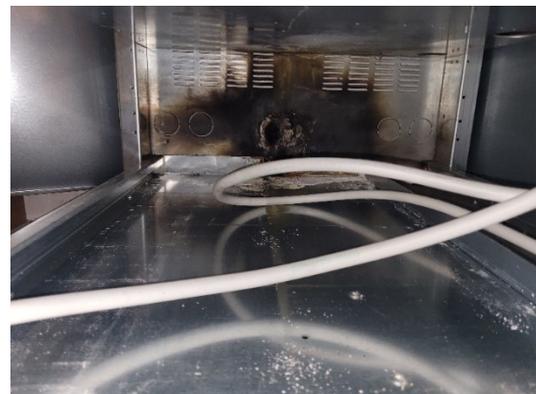
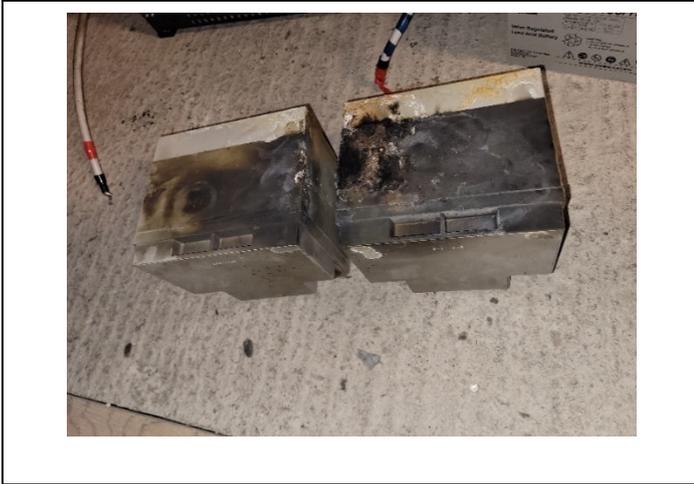
GS Yuasa were made aware that a small number of UK manufactured SWL1100FR lead acid batteries were found with a fissure on the corner of the battery container. Electrolyte leakage via this fissure results in localised corrosion to the battery shelf or tray. On occasion this has resulted in earthing (a "short"), causing blackening of the battery container and smoke.

Based on the testing carried out, GS Yuasa determined that the FR material used solely on SWL1100FR with a date code starting 22120728 until 24051428 is susceptible to impact damage. Impact could occur during storage, transit, positioning, handling & installation and can lead to a fissure even with no other evidence of damage to the container.

- Customer Recommended Preventive Action** - At maintenance visits check each battery shelf visually for signs of corrosion and additionally test for earthing by looking for either voltage or continuity between the battery string and the shelf it is placed upon. If any earthing, smoke or blackening is observed, the system should be isolated and reported to your local GS Yuasa contact (see Enquiries section for contact details).

From 15th May 2024 the ABS material used on the SWL1100FR was changed to an alternative approved supplier. This material was tested and passed drop and impact testing. As an additional measure, the SWL1100FR container tooling has also been modified to help reduce stress in the component and 3D design software was utilised to compare the stress before and after the change. The container modifications increased the radius of the internal corners and thickness of the internal side walls. After carrying out internal stress testing it was clear that product produced after these actions is substantially less susceptible to any external forces.
